Patching of Pavements by Stabilisation using Skidsteer Equipment

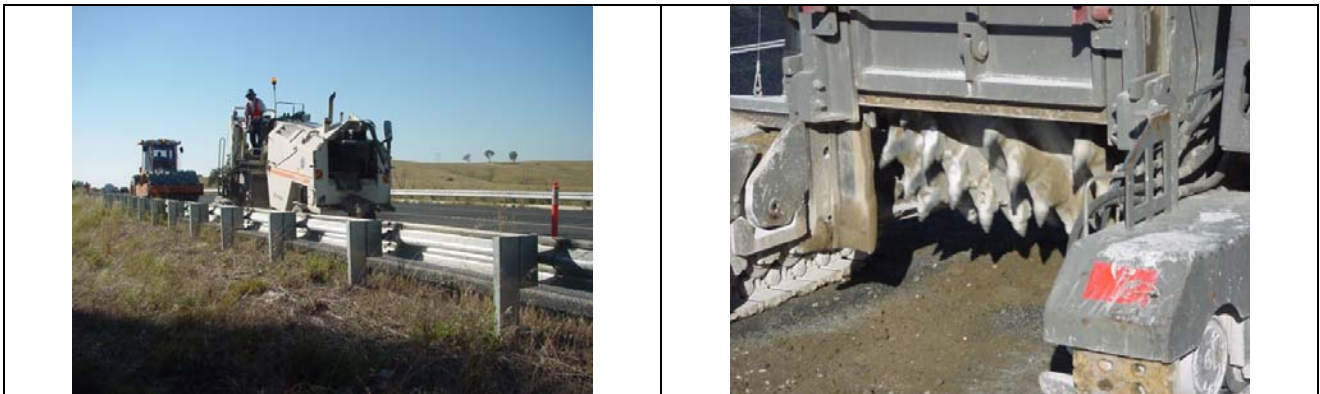
Figure 2 A profiler incorrectly used for road stabilisation in NSW due to the poor mixing quality.
(Photo taken in March 2000)

There was no evidence in the study that the binder was effectively mixed with the various profiler attachments. Visual evidence of profilers being used for stabilisation in NSW, WA and Queensland over the last 15 years has shown poor quality mixing [AustStab, 2000a] as shown in Figure 2.

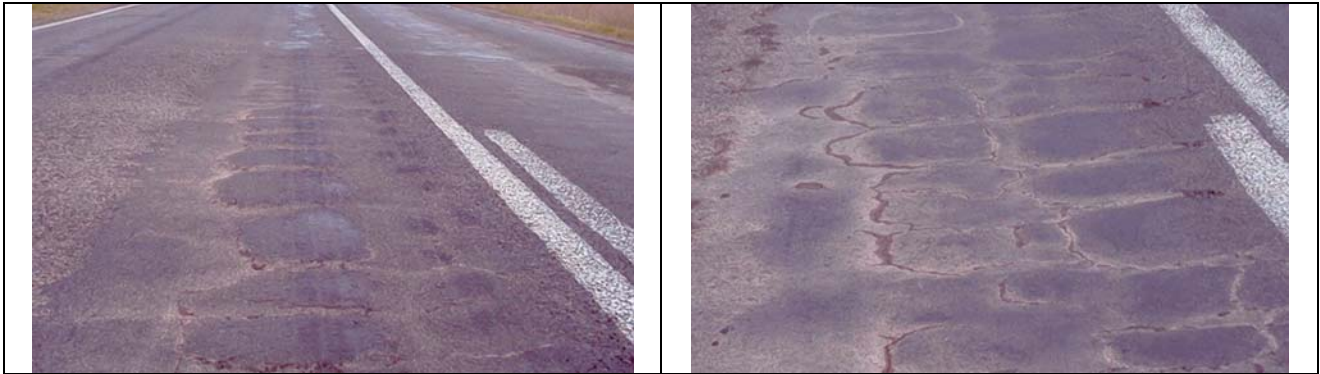
Figure 3 A view failed stabilisation patching on the Hamilton Highway at Derrinallum.
(Photo taken in May 2003)

Patches completed using the skid steer process have a relatively short life and tend to fail in the block cracking mode (see Figure 3).
