Site investigations for the rehabilitation of low-trafficked roads using insitu recycling

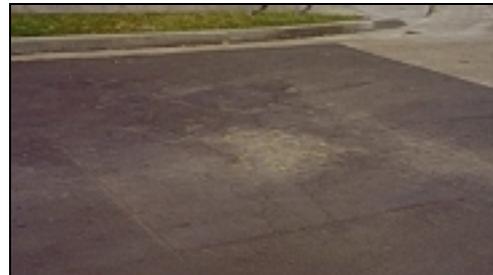
Figure 1 This patch did not resolve the underlying subgrade strength deficiencies.

- condition of the pavement [refer to Figure 1]
- drainage patterns and existing structures
- topography and geology the road traverses [refer to Figure 2]
- location of services, grates, manholes, access to properties, trees etc [refer to Figure 4]
- proximity of residential and business properties
- traffic composition i.e. bus route etc, and some roads are busier than they seem.

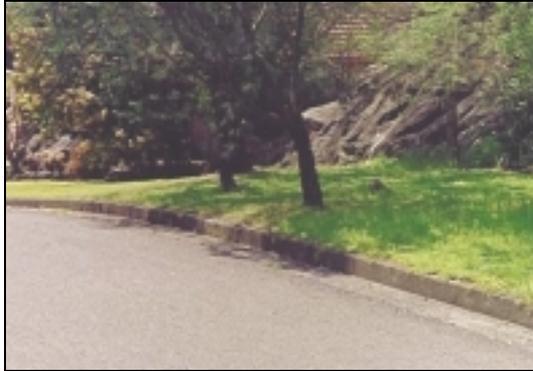
Figure 2 The closeness of the rock adjacent to the footpath indicates that rock is close to the surface or rock floaters may be near the surface.

The topography and geology of the land through which the road traverses can provide valuable information on the reasons for pavement failure. Topography relates closely to drainage. Particular attention needs to be given to pavements over flat terrain and in cuttings. Close examination of soil profiles in cuts and other geological information can provide information on subgrade conditions or materials.

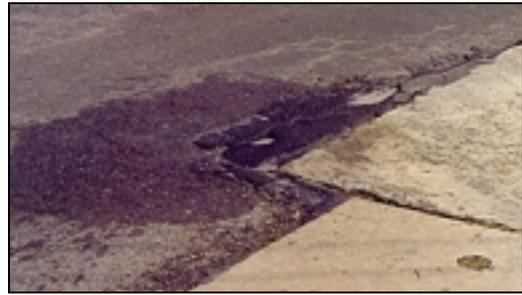
Figure 3 The presence of localised surface water indicates that there is a problem with drainage of the pavement material.

The presence of ponded water [see Figure 3], water level marks and grass growth during dry periods is indicative of drainage problems and need to be investigated.

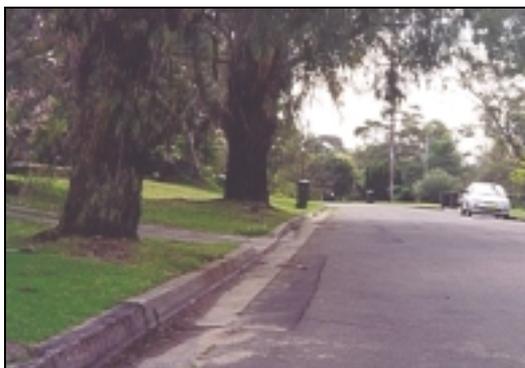
Figure 4 The presence of large trees close to the kerb need to be identified.

The location of manholes, grates, services etc should be determined so as to allow decisions to be made on the need to lower or remove such obstructions for the rehabilitation process. In some areas tree conservation policies may preclude the use of some types of machines. Adjacent or overhanging trees needs to be identified and located [see Figure 4].

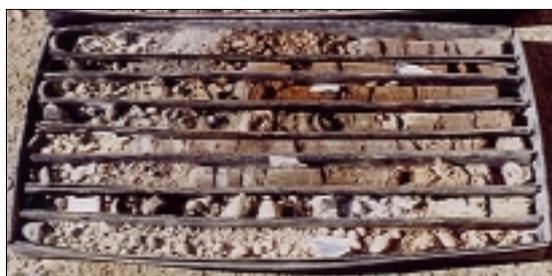
Figure 5 The existing pavement material can vary significantly in some locations.
